A STUDY OF IN-PLACE RUTTING OF ASPHALT PAVEMENTS

**E.R. Brown
Stephen A. Cross**

National Center for Asphalt Technology

NCAT Report No. 89-2

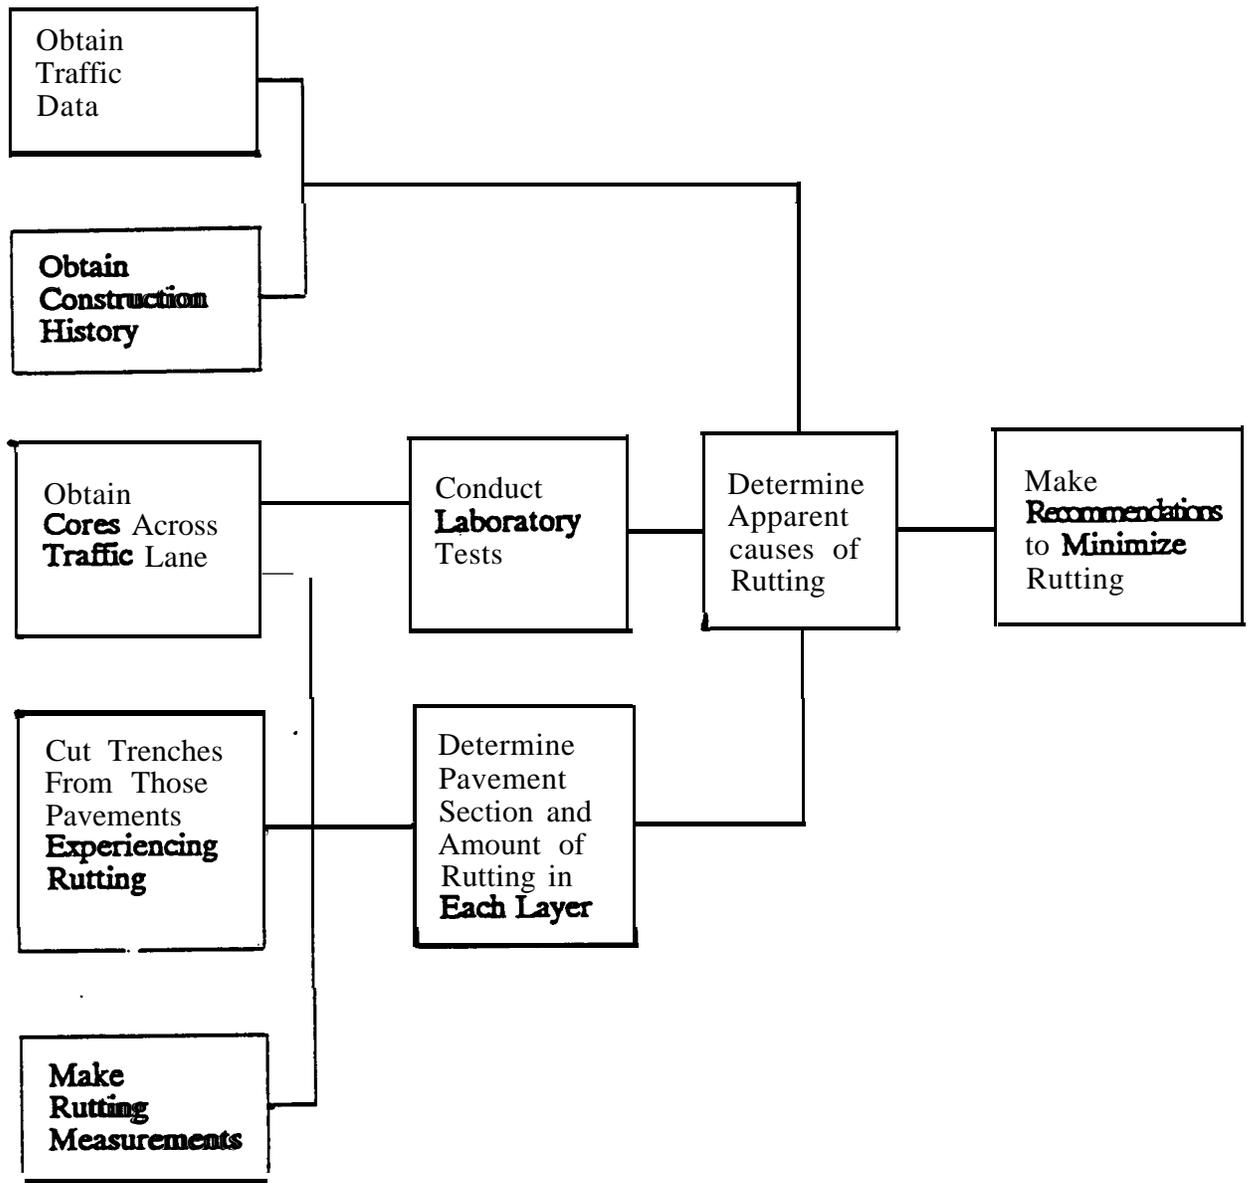
Figure 1. Overall Test Plan.

The overall test plan for the rutting study is shown in Figure 1. The plan of laboratory tests for the cores taken from the pavements is shown in Figure 2.

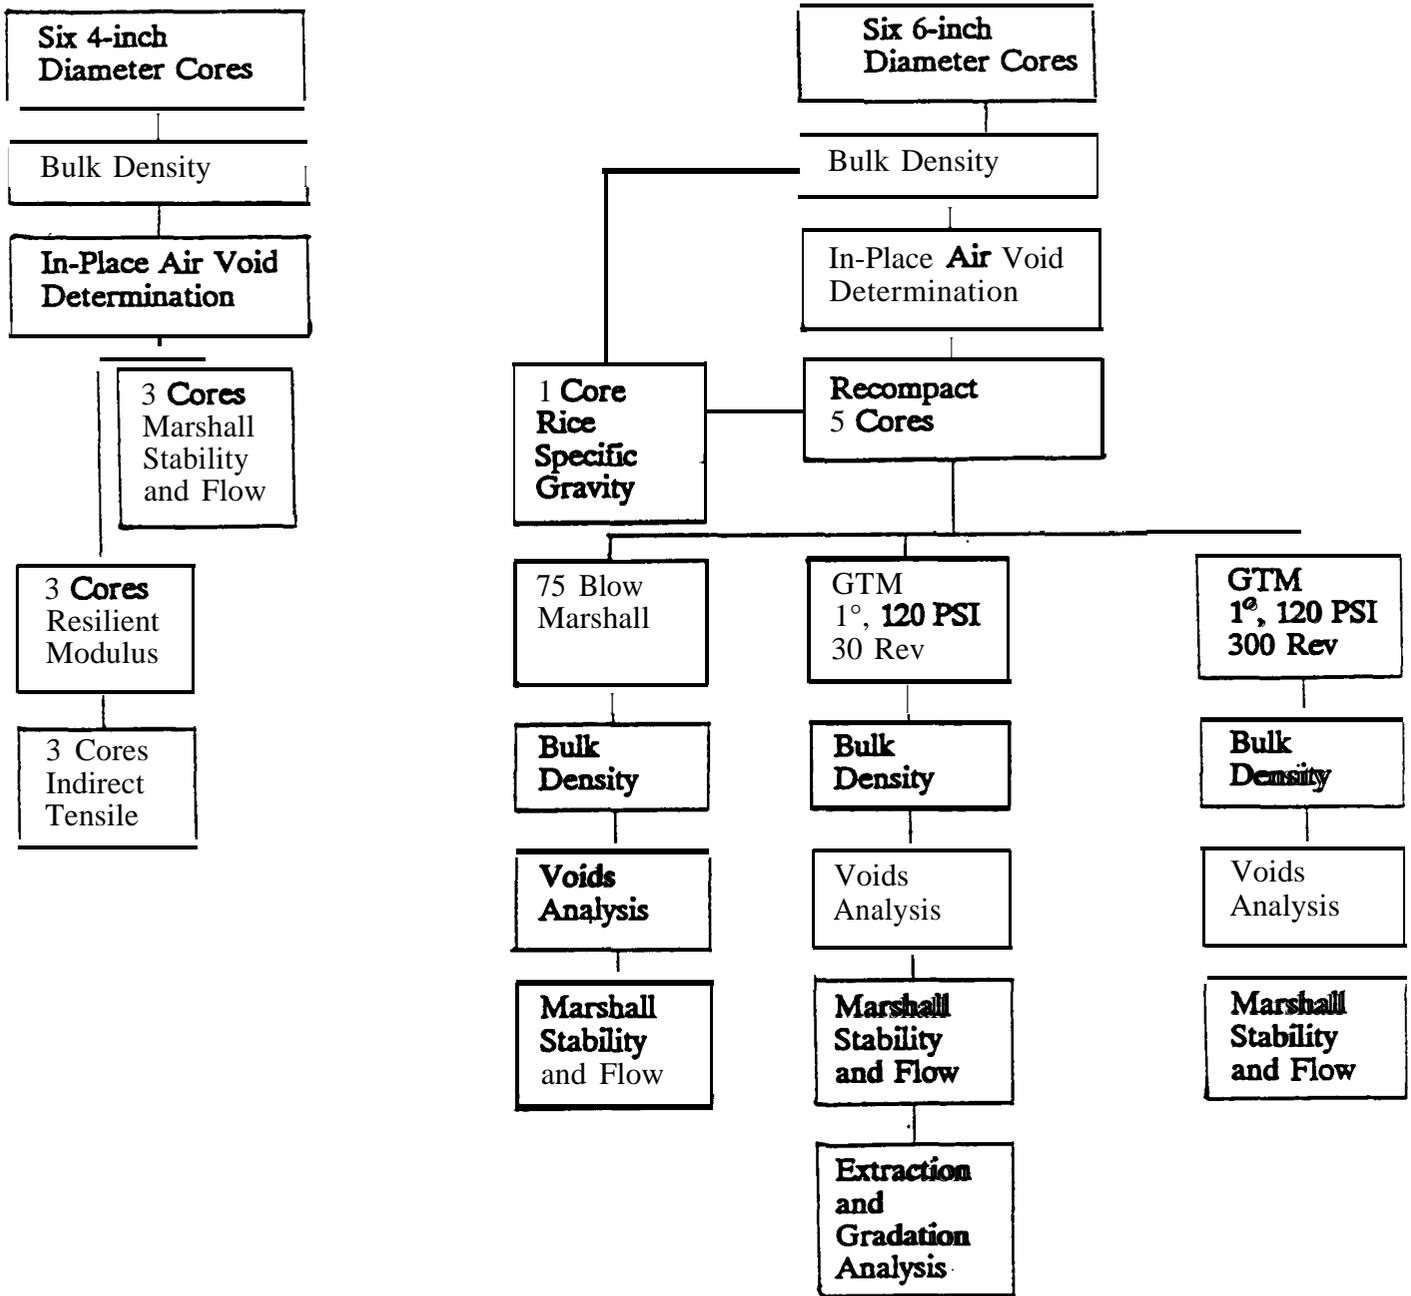
Figure 2 **Laboratory** Test Plan

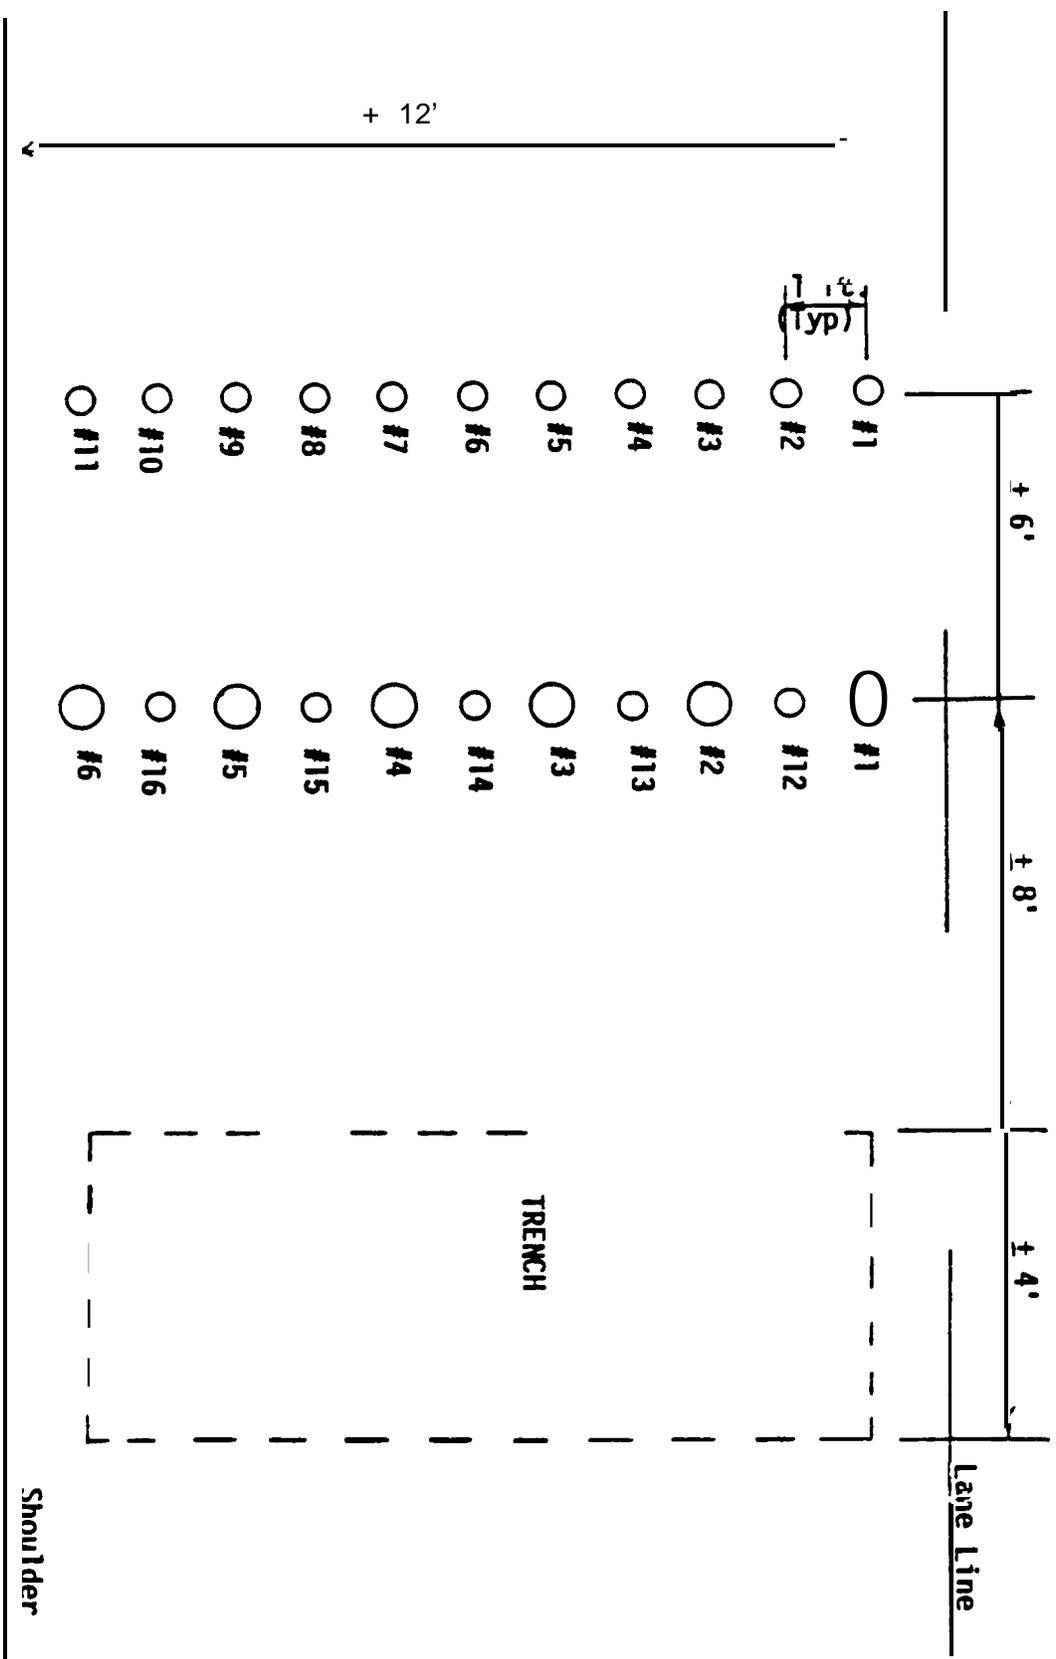
Figure 3. Core Sampling Pattern

determine the locations in the asphalt mix that rutting was occurring. A layout of the cores and trenches for each site is shown in Figure 3. A **stringline** was pulled across the top of each pavement layer inside the trench to aid in determining the location of the rutting. A typical trench with **stringline** pulled across the top the of second layer is shown in Figure 4.

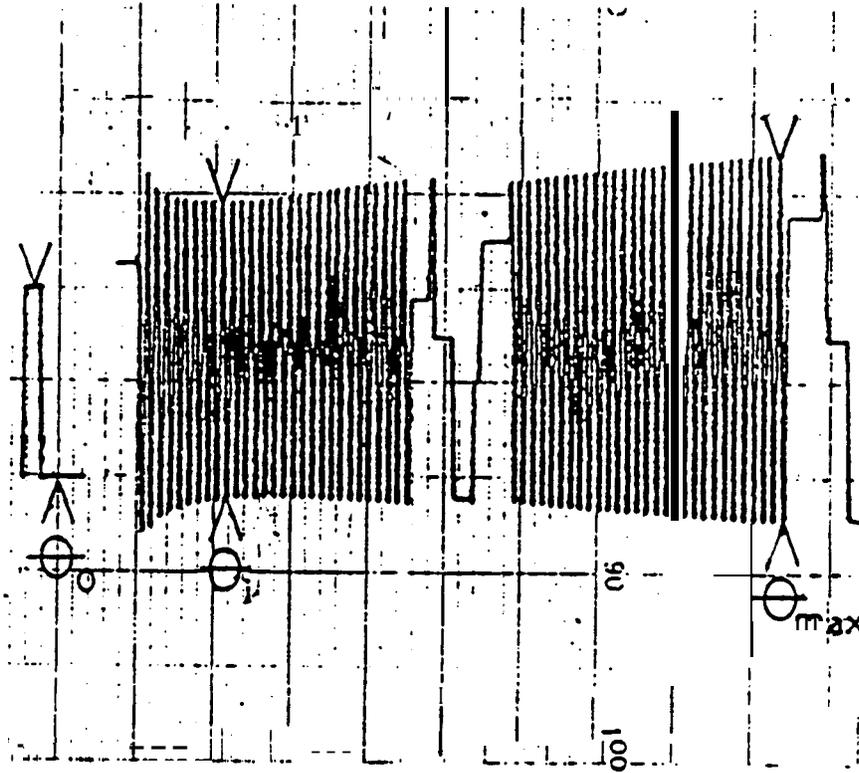
$$GSI = \theta_{max} / \theta_1$$

Figure 5. Determination of GSI from Typical Gyrograph

The Gyratory Shear Index (**GSI**) was determined for all samples compacted **in** the **GTM**. A **GSI** of 1.0 is normal for a mixture that is stable during compaction. A higher **GSI** has been shown to indicate more unstable mixtures. A plot demonstrating determination of **GSI** is shown in Figure 5. Compaction of asphalt in the **GTM** simulates **densification** and eventual plastic flow that is observed in the field. An asphalt mix is stable until voids are closed during compaction to the point that plastic flow begins to occur. **An** increase in **GSI** above **1** measured during compaction in the **GTM** simulates plastic flow **in** the field.

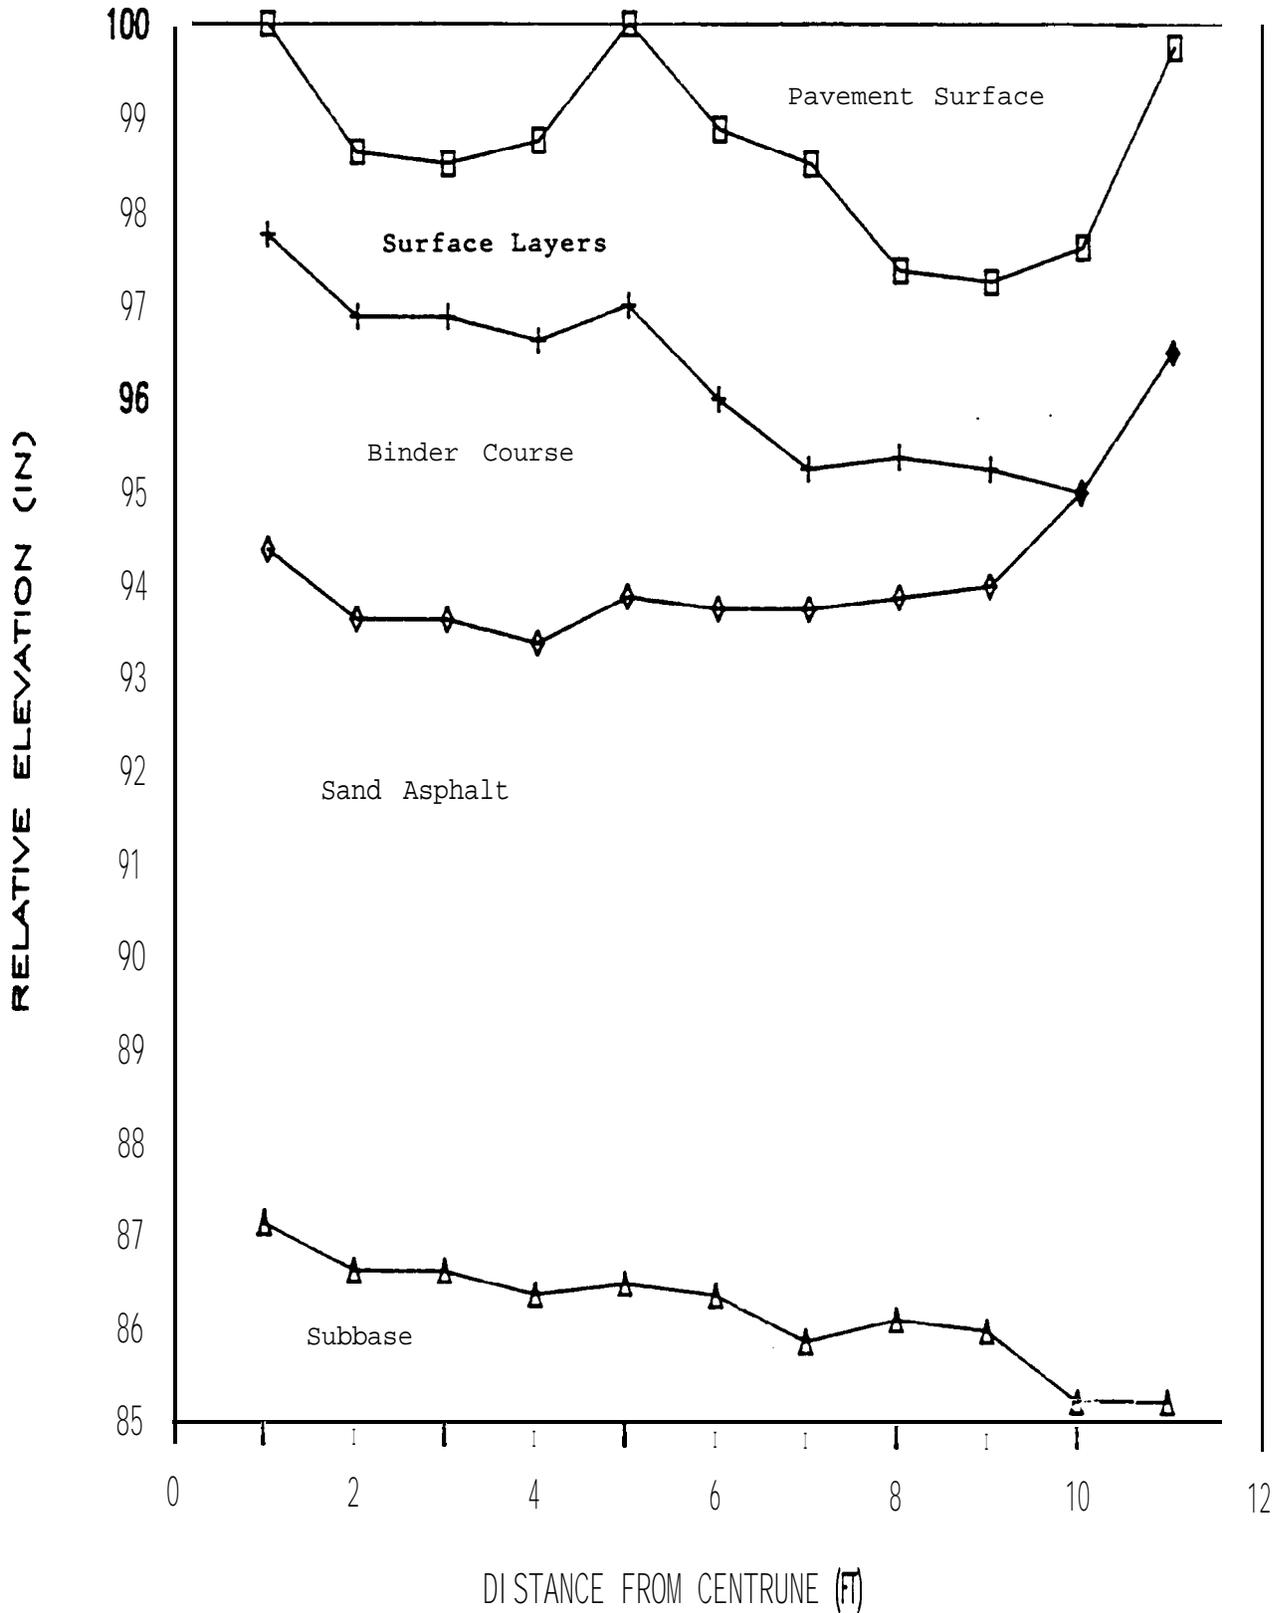
Figure 6. Relative layer elevation vs. distance from centerline for Site #1

It is clear from Figures 5,6, and 7 that a significant amount of **rutting had** occurred in the surface of the pavement at site 1. This particular pavement had experienced rutting in the past and had been milled, patched, and overlaid at various times to alleviate the rutting problem. The large amount of maintenance work explains why the various layers vary **in** thickness and grade. After **observing** the trench for site 1 and closely reviewing Figure 6 it is apparent that most of the rutting had **occurred** in the surface layers (the surface layers consisted of three thin layers of asphalt mix).

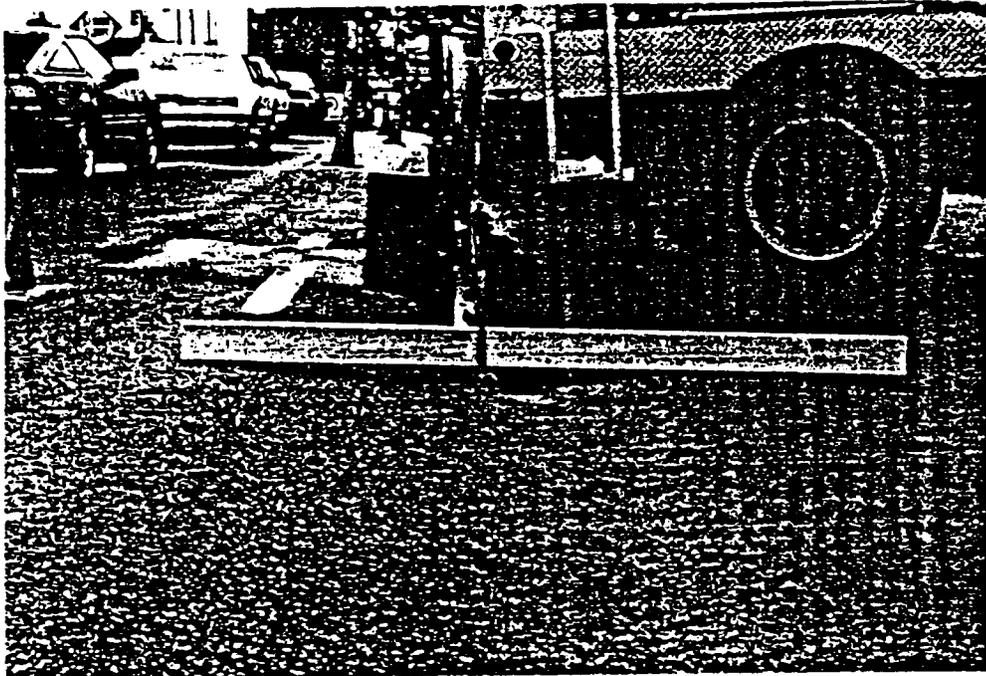
Figure 7. Typical Rutting at Site #1.

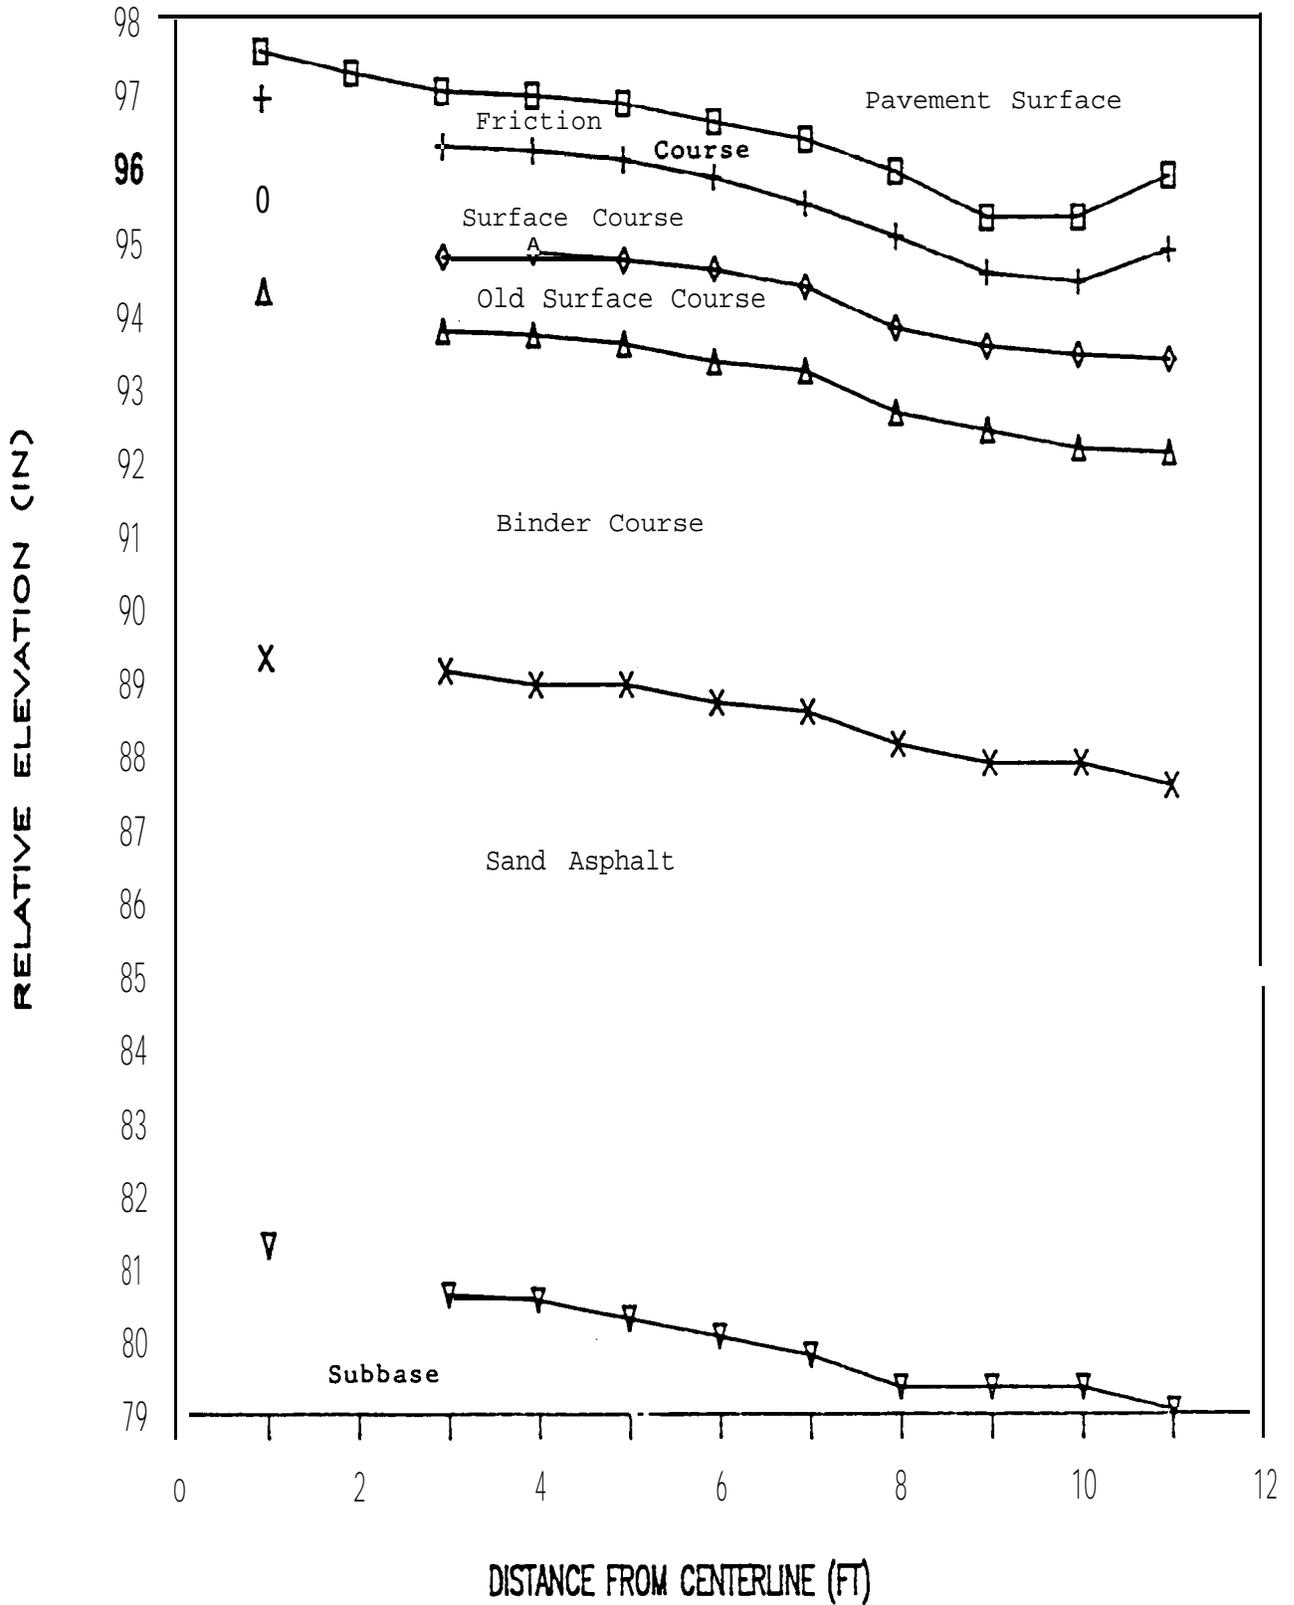
Figure 8. Relative layer elevation vs. distance from centerline for Site #2

Figures 8 and 9 show that a small rut had occurred adjacent to the shoulder for the pavement at site 2. Very little rutting was **observed** adjacent to the centerline. The shoulder paint stripe had moved in some locations which is often a result of stripping. The rutting at this site appeared to be partially related to stripping which explains why the rut is adjacent to the shoulder (source of water). **Observations** while cutting the trench and during the laboratory testing operation showed a **significant** amount of uncoated aggregate which was concluded to be stripping.

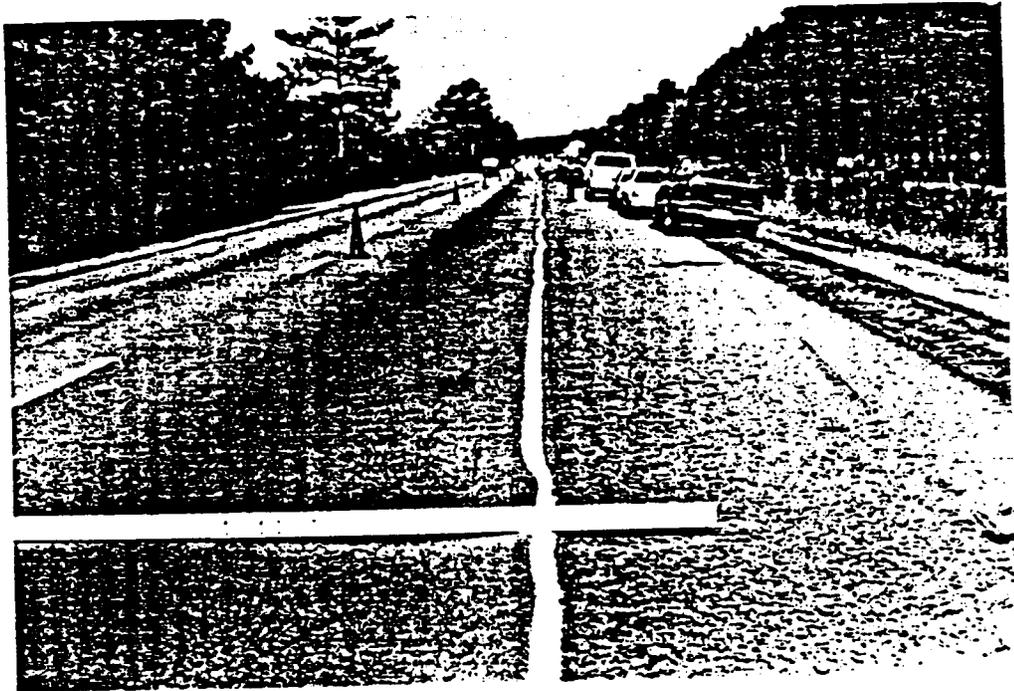
Figure 9. Typical Rutting at Site #2

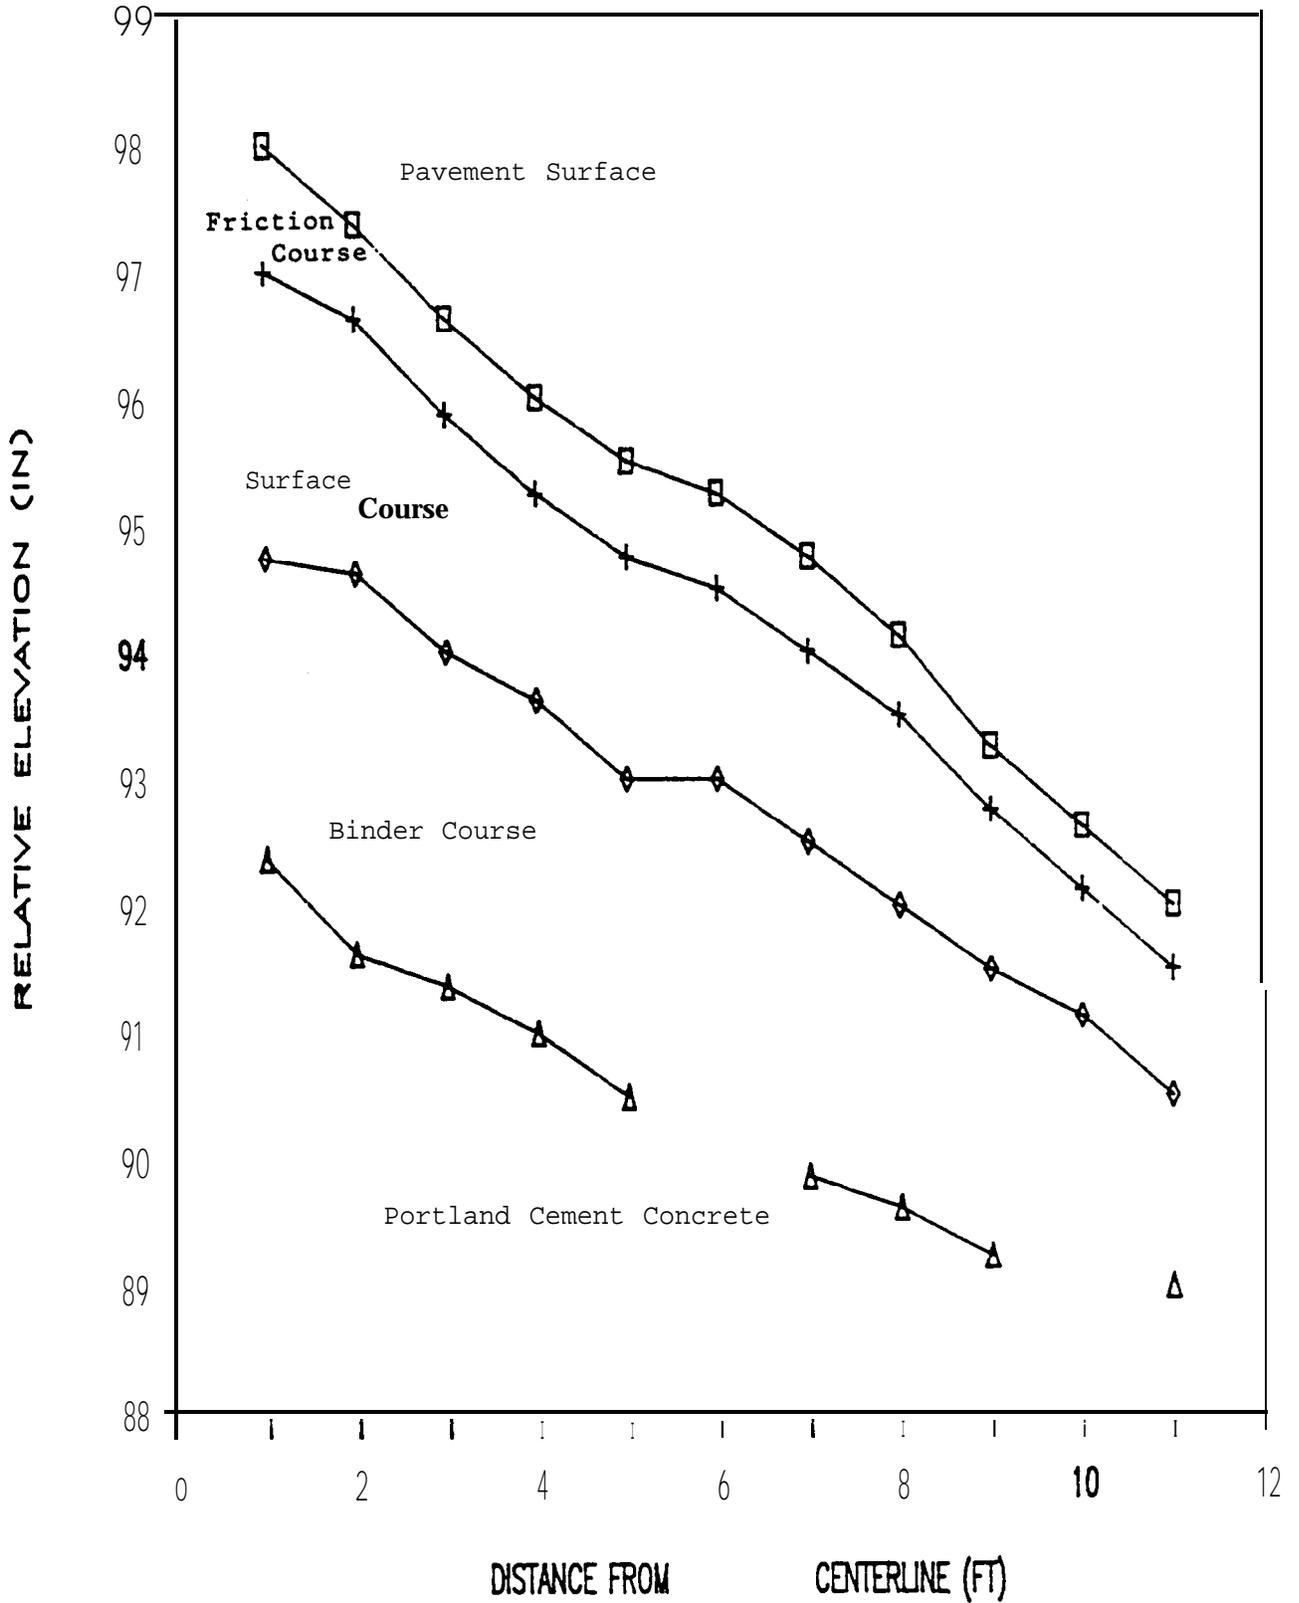
Figure 10. Relative layer elevation vs. distance from centerline for Site #3

Measurements taken at site 3 showed very little rutting (Figures 10 and 11) however there were locations where the material had shoved outward adjacent to the shoulder. These were localized areas and did not result in significant rutting. Site 3 consisted of an old PCC pavement which had been overlaid with asphalt concrete. The asphalt mix contained primarily uncrushed aggregate **and** had clearly stripped. During the trenching operation many aggregate particles were **observed** that had been completely stripped of asphalt. It is anticipated that the high amount of stripping and the localized shoving that has begun will very rapidly lead to a significant rutting problem.

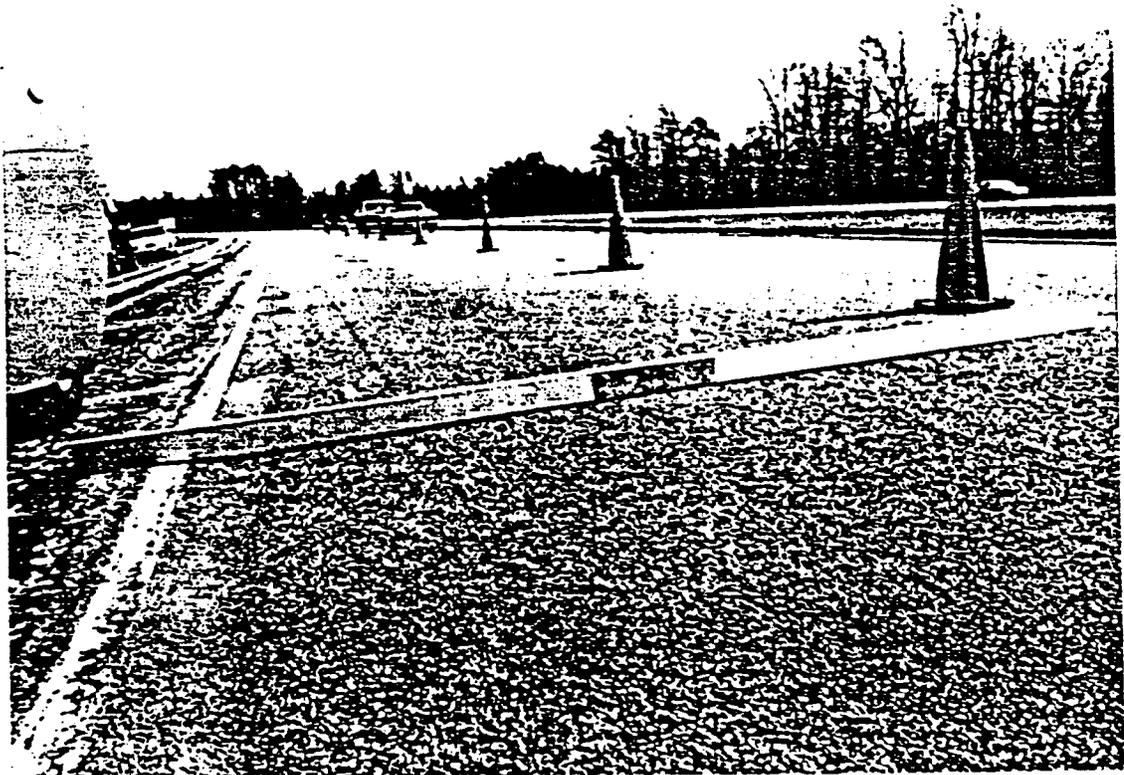
Figure 11. Typical Rutting at Site #3.

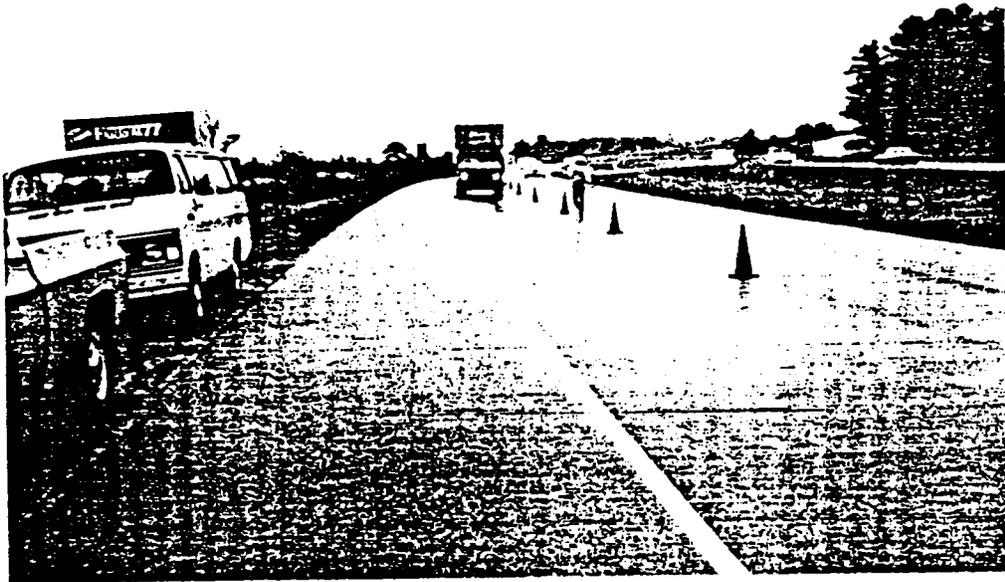
Figure 12 Asphalt Mix with Excellent Performance at Site #4.

Site 4 was selected as a pavement that had performed over ten years with no major performance problems (Figure 12). The **plot** in Figure 13 shows that this asphalt mix has a small rut but this did not appear to be a typical rut. The surface was perfectly straight except for a slight dip at 8 feet from the centerline. This depression was well within the allowable tolerance of construction variation and obviously had no effect on the traffic using the roadway.

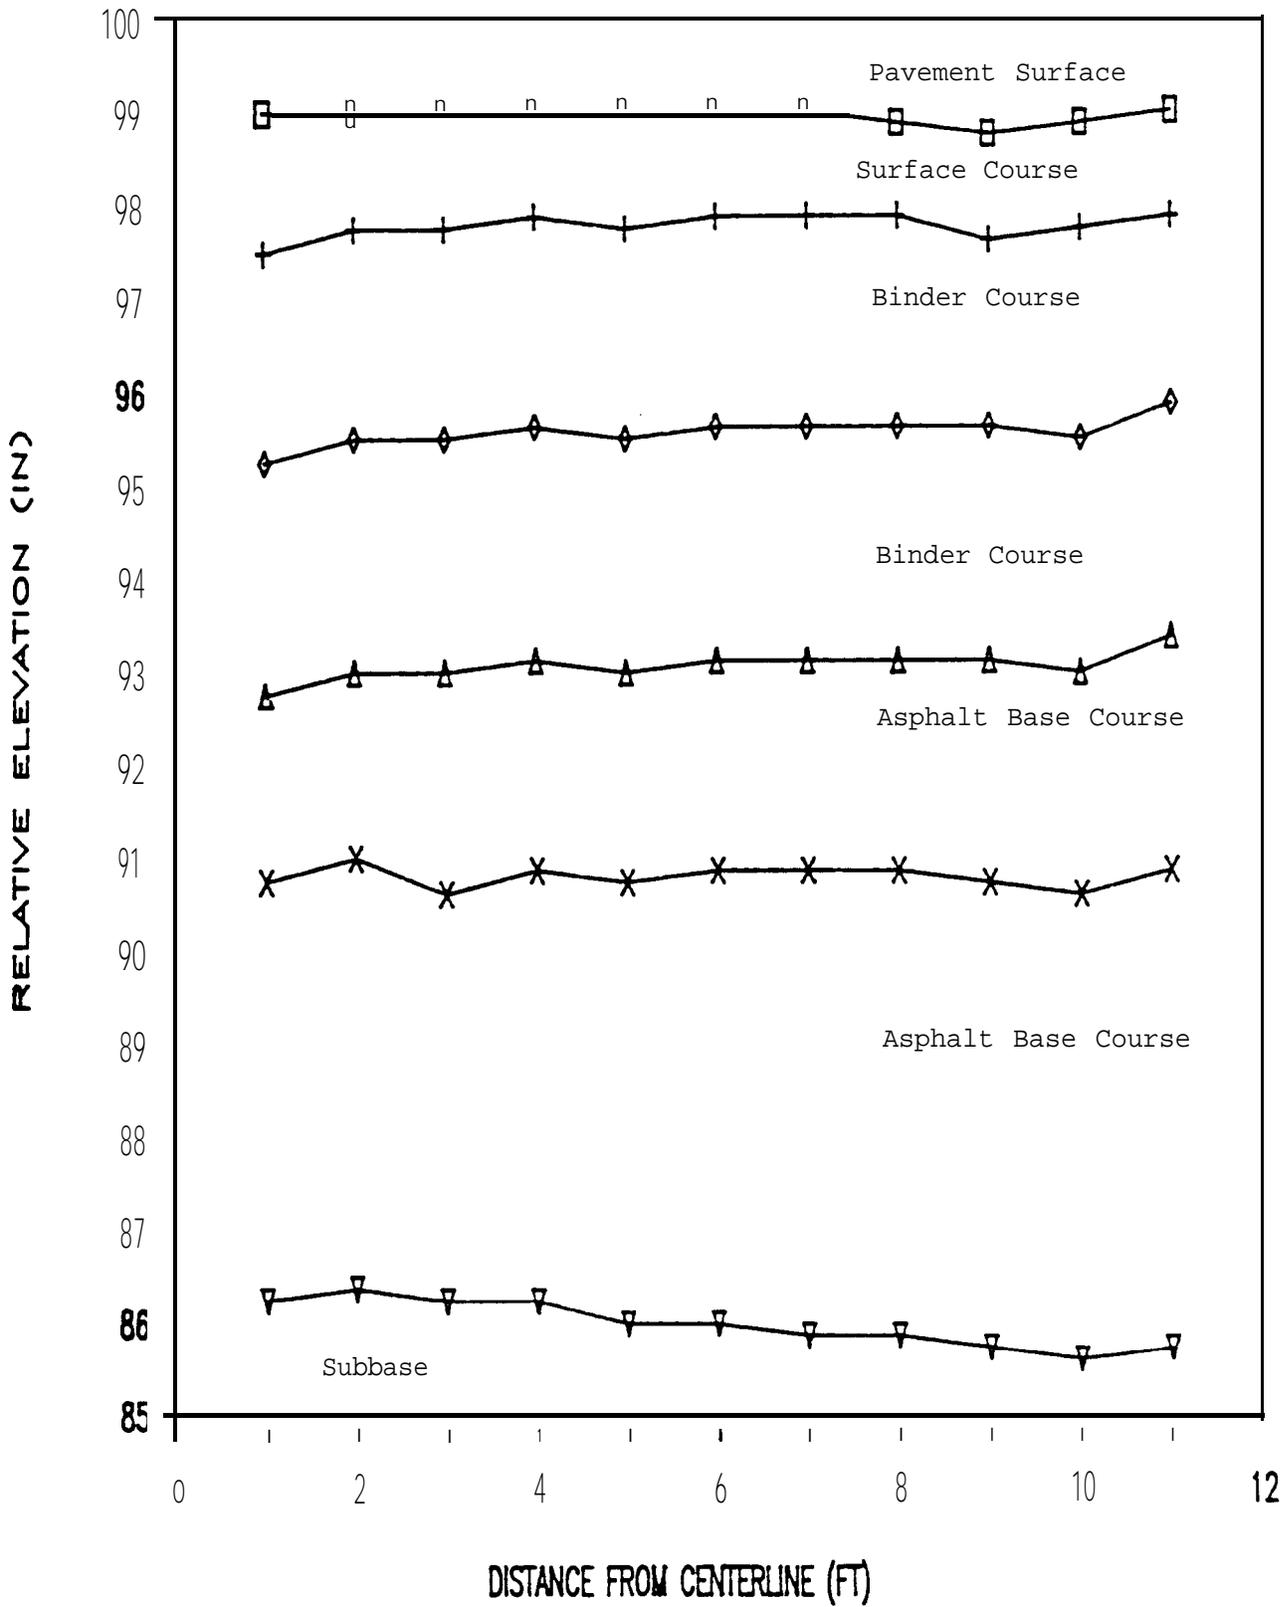
Figure 13. Relative layer elevation vs. distance from centerline for Site #4

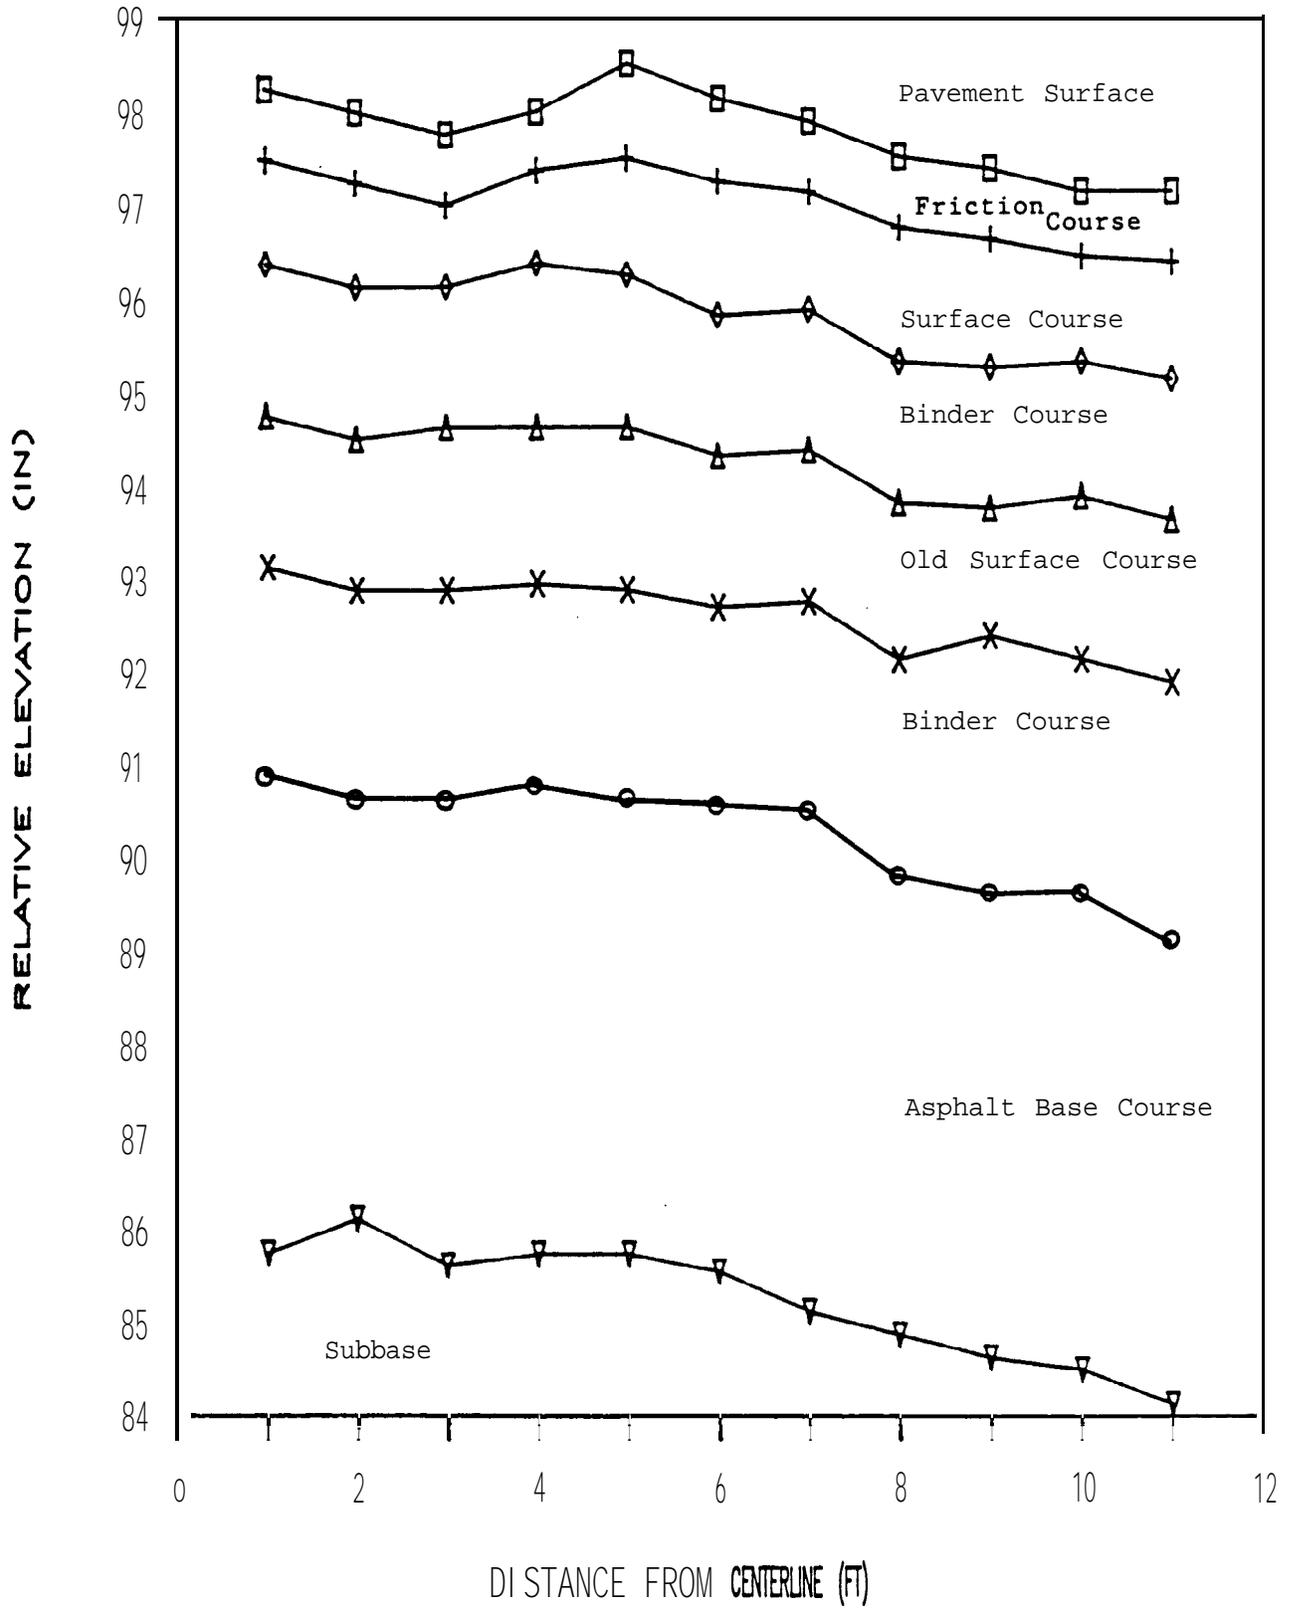
Figure 14. Relative layer elevation vs. distance from centerline for Site #5

Site 5 had experienced some rutting primarily adjacent to the centerline. Figures 14 and 15 show that most of the rutting here had occurred in the friction and surface **course**. Cores were obtained during rain and it was clear that the rut adjacent to the centerline held water.

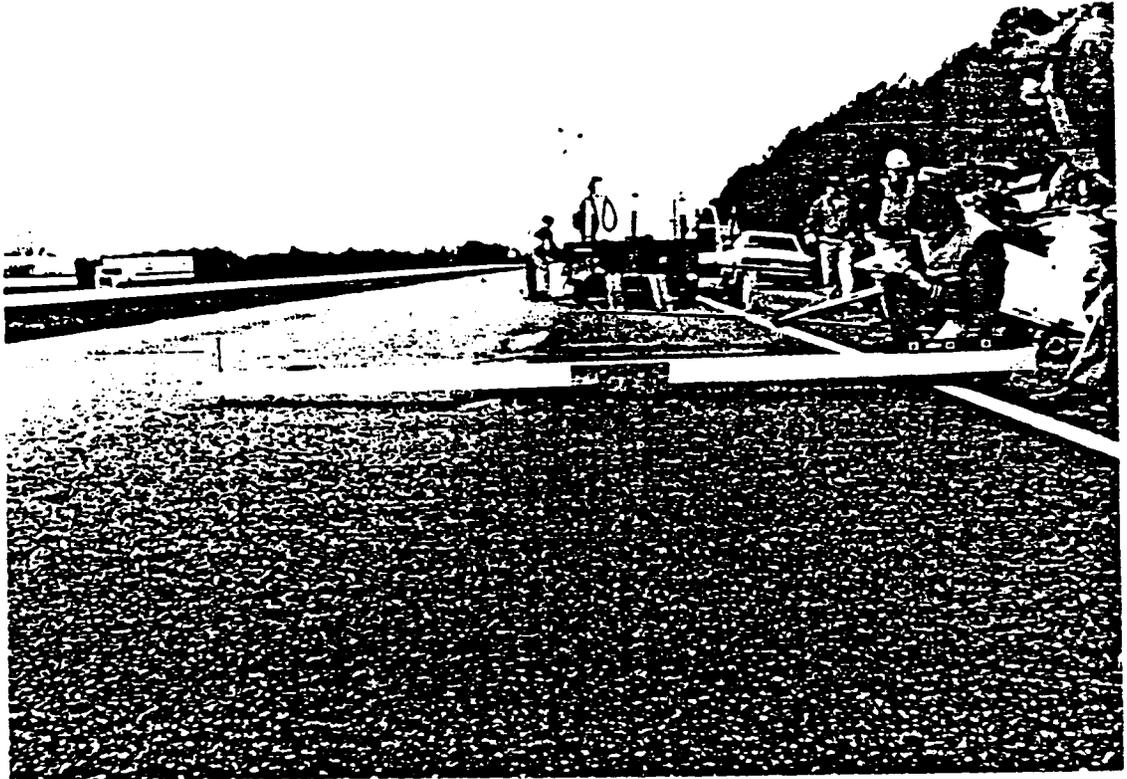
Figure 15. Typical Rutting at Site #5.
